# Army and Navy Flyover ECC Bridge No. 1000

**Column Movement Investigation Report**

23<sup>rd</sup> October, 2018

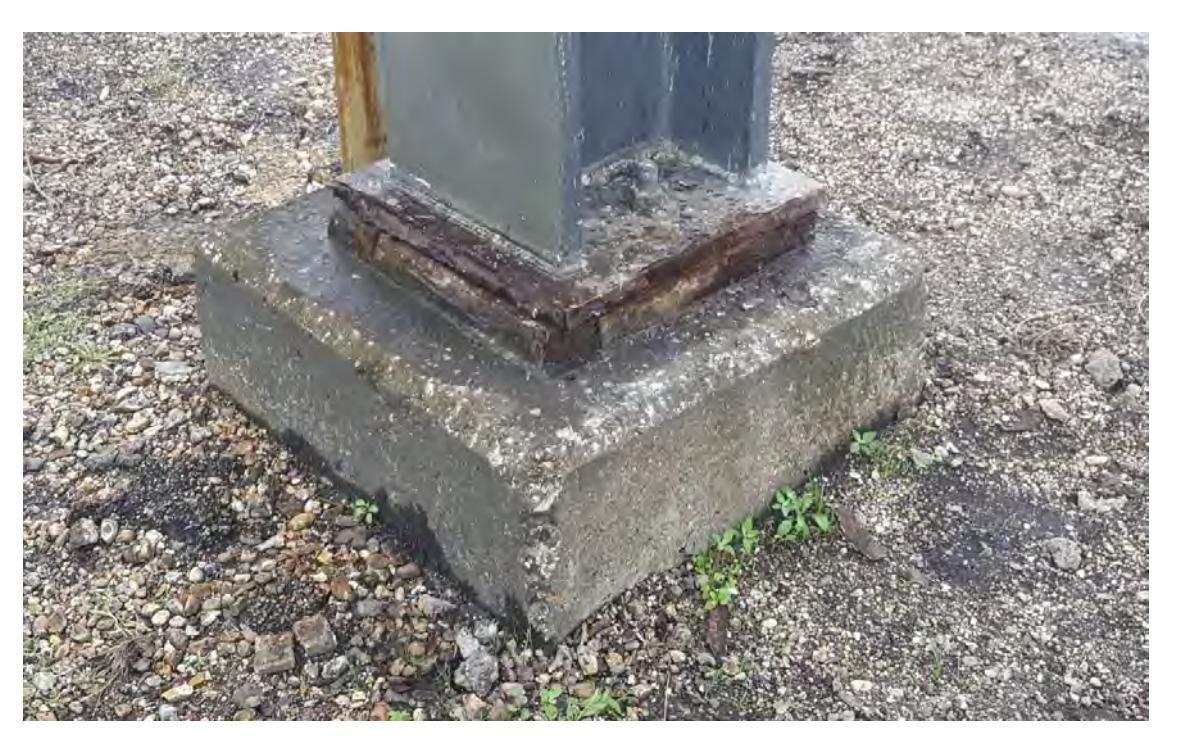
15mm overall southward movement of the base plate. Approximately 30° inclination of eastern holding down bolt which has not fractured. 24mm southward movement of the western holding down bolt, which has fractured.

Figure 2: Trestle T6 – north column baseplate, facing south-east

Preliminary analysis indicates that replacement of the M24 grade 8.8 bolts is a suitable interim measure until a more rigorous assessment of the structure is undertaken, particularly into the effect of thermal expansion under high temperature.

Replacement bolts should be corrosion resistant, such as galvanised or stainless steel, with suitable isolation to prevent bi-metallic corrosion of baseplates. It is recommended that the condition of the holding down bolts at the other trestles are investigated within the next 6 months and replaced if there are signs of significant corrosion or section loss.

At the time of writing, it is understood that M30 grade 10.9 bolts are being installed at Trestles T6 and T7 which will provide a significantly increased capacity.

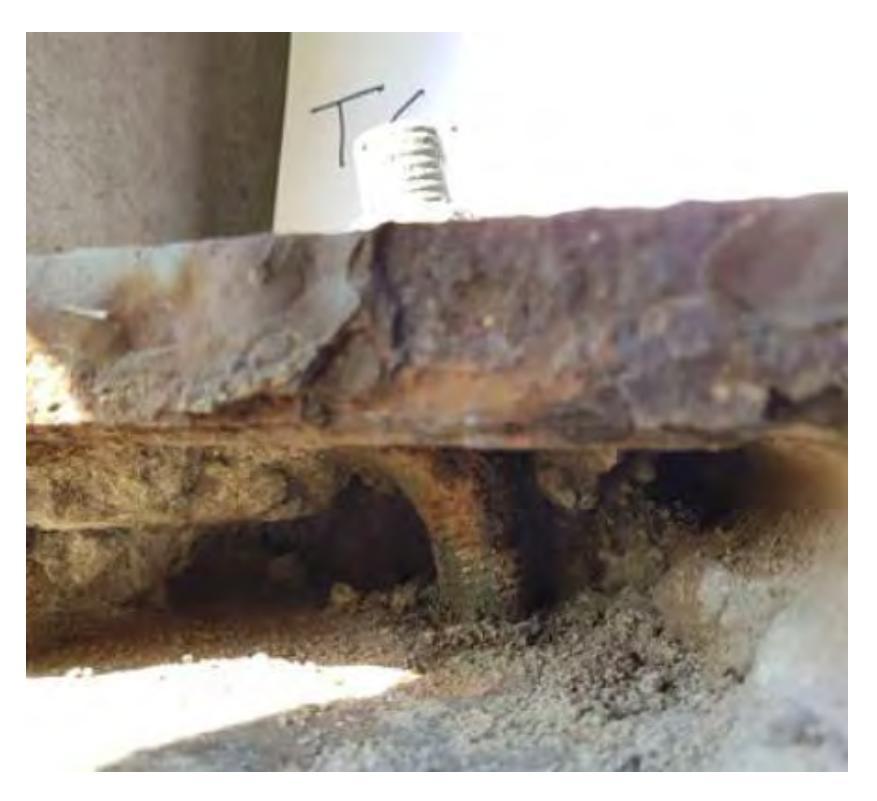
Figure 3: Trestle T6 – north column, east holding down bolt (inclined)

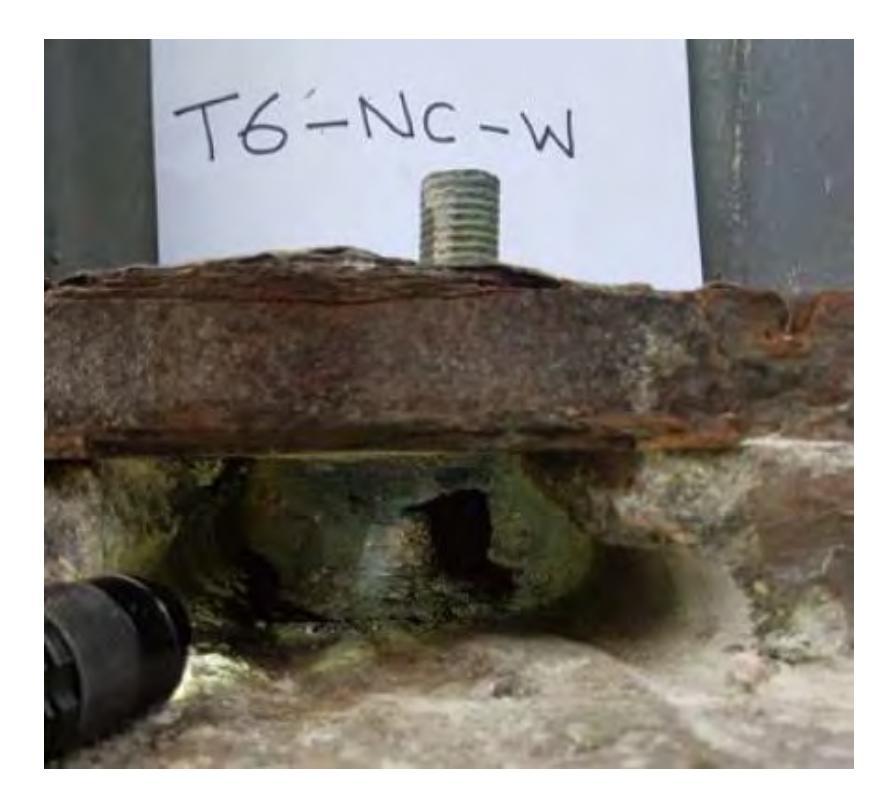
Figure 4: Trestle T6 – north column, west holding down bolt (fractured)

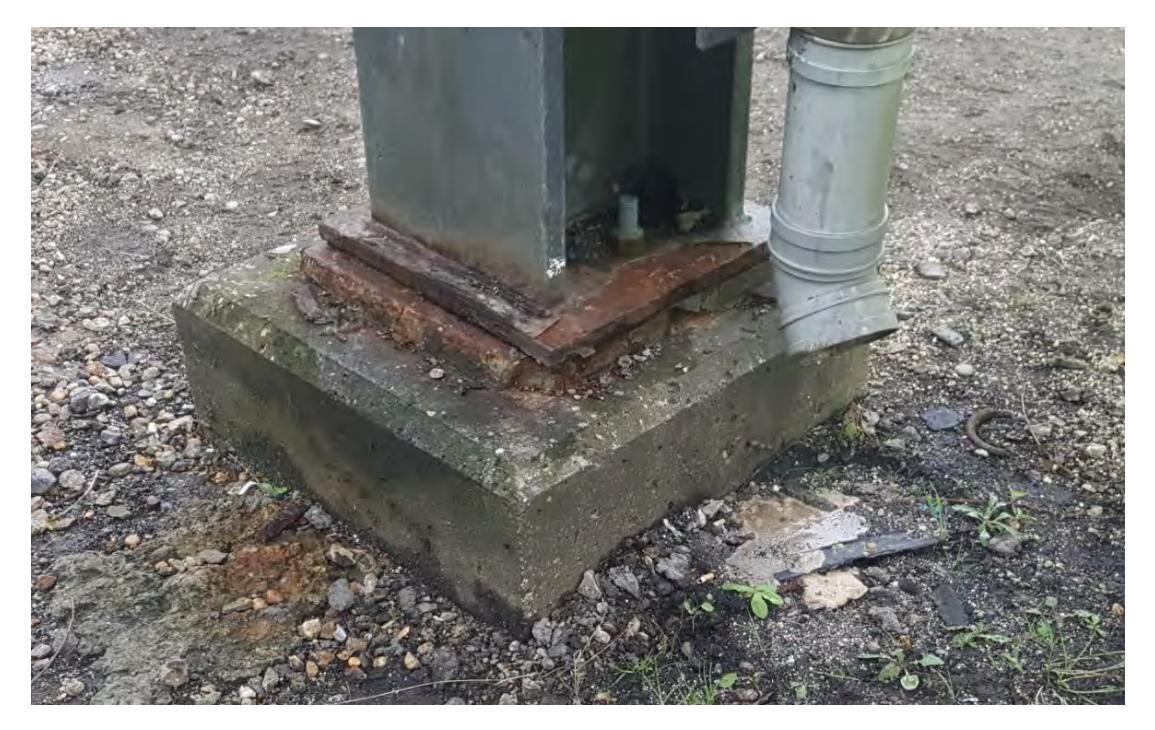
32mm southward movement of base plate and both holding down bolts (both fractured).

Figure 5: Trestle T7 – north column baseplate, facing south-east

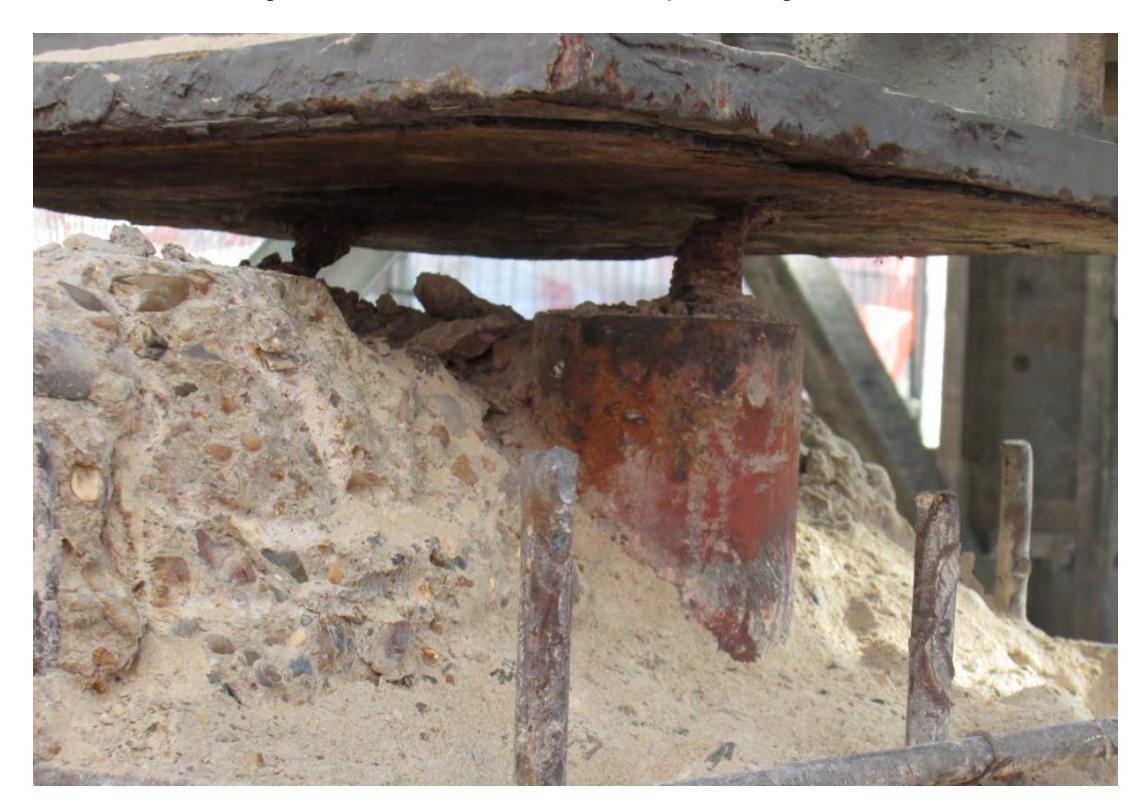
Figure 6: Trestle T7 – north column, east & west holding down bolts (fractured). Plinth concrete broken out during site investigation and propping works

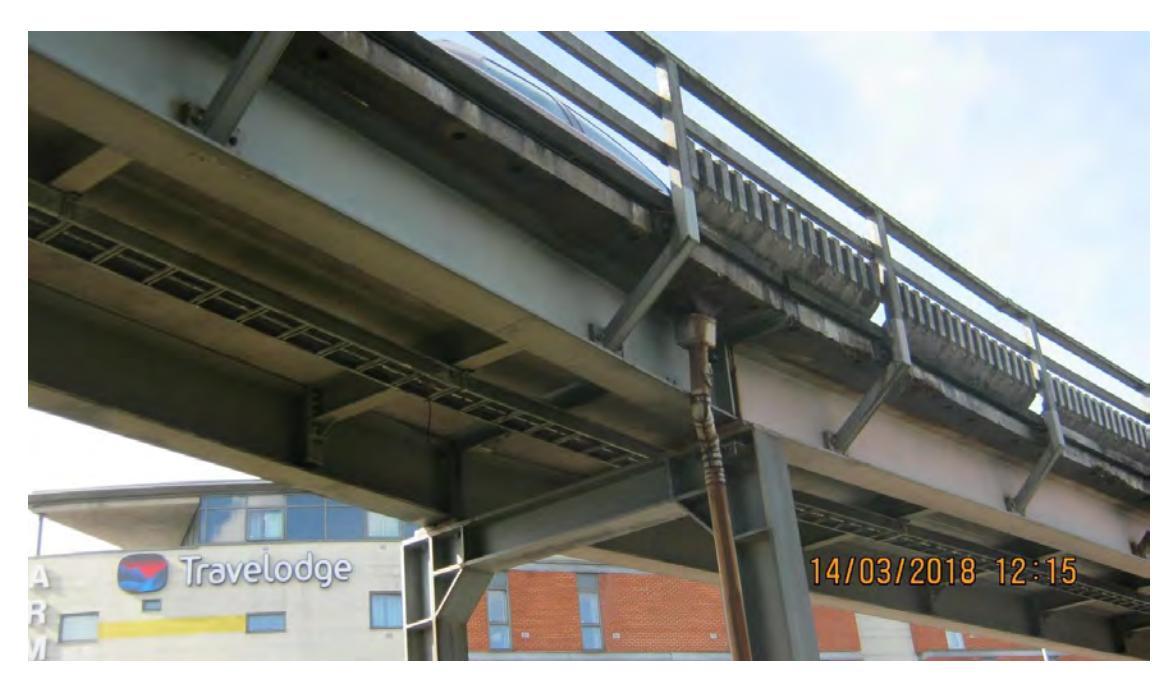
Significant expansive corrosion product, such as that observed at the cast iron bearings, end plates, bolts and thrust pads, could affect the joint assembly, reducing the capability of the thrust pads to absorb thermal expansion forces between adjacent decks.

Figure 7: View of typical deck and joint (facing southwest)

It is recommended that further investigation be undertaken to examine the effects from continuing thermal expansion cycles on the structure so that an adequate long-term solution can be designed and implemented. This should include investigation of the effectiveness of the thrust pads at the abutments and at the ends of each deck span.

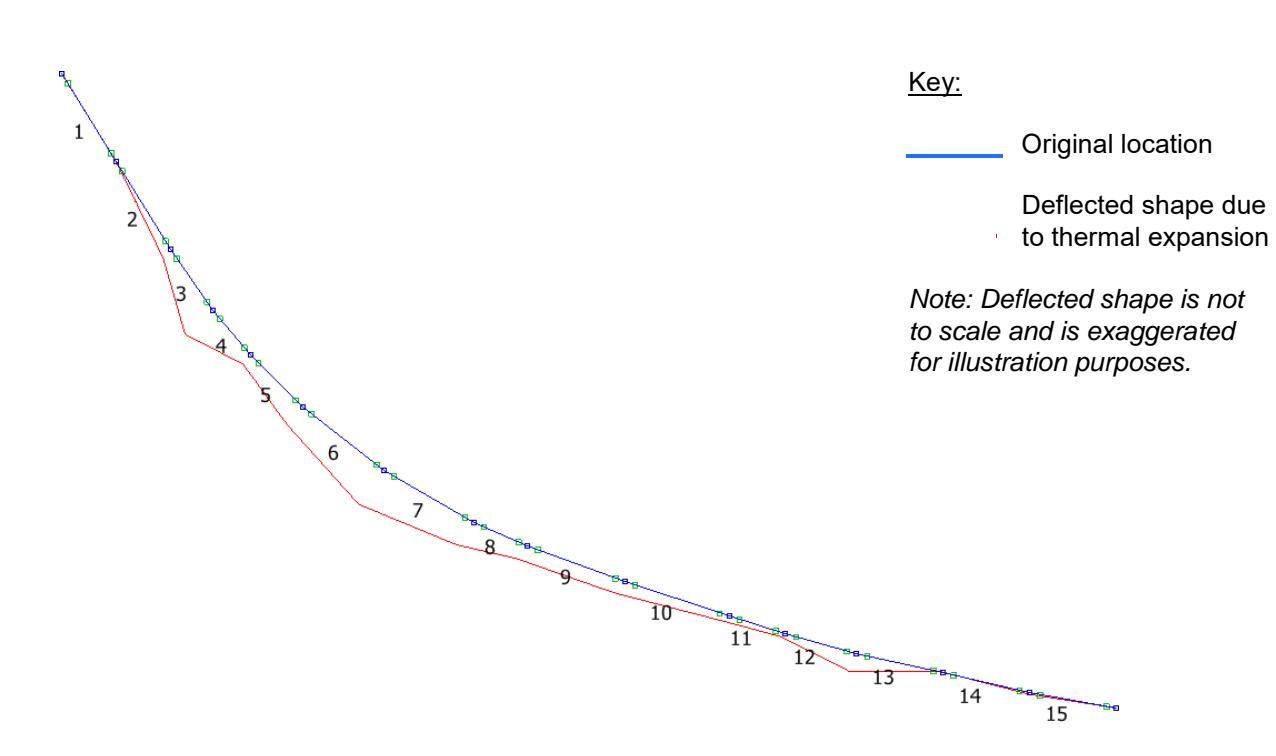
A more advanced 3D modelling analysis was not feasible due to the time constraints imposed by the urgency of the initial investigation and by the need for materials testing to ascertain the nature of the thrust pad materials. From this conservative model it was determined that significant sway could potentially be experienced at a number of trestles including T6 and T7. It also confirmed, as expected, that under thermal expansion the global sway behaviour is southwards and is at its greatest at trestles T6 and T7.

Figure 8: Line beam model of Army and Navy flyover.

The temperature increase required to generate a 42mm head sway movement in the model at Trestle T7 was estimated to be only  $+15^{\circ}$ C. Based on the recorded high deck surface temperatures over the period in which the failure is claimed to have occurred, it is considered likely that the positive temperature change in the deck would have been in excess of  $+15^{\circ}$ C.
