Project Completion Notification

PUBLIC BRIDLEWAY 239 BASILDON (part) SURFACE IMPROVEMENTS

LBAS188001 - Bridleway 239 near Fern Walk, Langdon Hills, Basildon

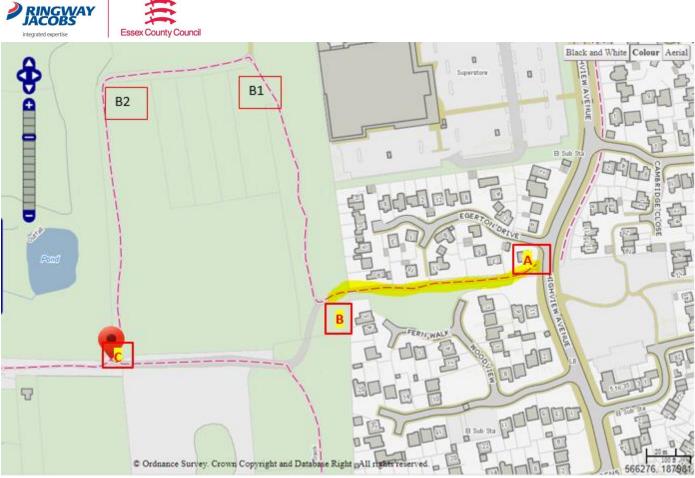
Part A); (A-B)

Part B), (B-C)

- Between B1 and B2 the bridleway slopes and could be prone to erosion so material will need to be firmly compacted to allow for run off.

- Approximately 165m of strimming back and cutting back overhang to height of 4m to allow for a clear width of 2.2m width to allow users on horseback to travel along.
- Overlay of clean crushed road planinigs or similar MOT Type1 for a distance of 165m tied onto the current surface and compacted to a camber with an approximate depth of 40 to 50mm with a covering of granite/limestone dusting to a depth 20 to 10mm depth across a 2.2m width

- Approximately 520m of strimming back and cutting back overhang to height of 4m to allow for a clear width of 2.2m width to allow users on horseback to travel along (this was done in conjunction with Essex Wildlife Trust advice)

- Overlay of clean crushed road planinigs or similar MOT Type1 for a 195m distance tied onto the current surface and compacted to a camber with an approximate depth of 40 to 50mm with a covering of granite/limestone dusting to a depth 20 to 10mm depth over a width of 2.2m and then, overlay of clean crushed road planinigs or similar MOT Type1 for a 325m distance tied onto current surface and compacted to a camber with an approximate depth of 40 to 50mm with a covering of granite/limestone dusting to a depth of 40 to 50mm with a covering of granite/limestone dusting to a depth of 40 to 50mm with a covering of granite/limestone dusting to a depth of 40 to 50mm with a covering of granite/limestone dusting to a depth 20 to 10mm depth over a width of 3.5m

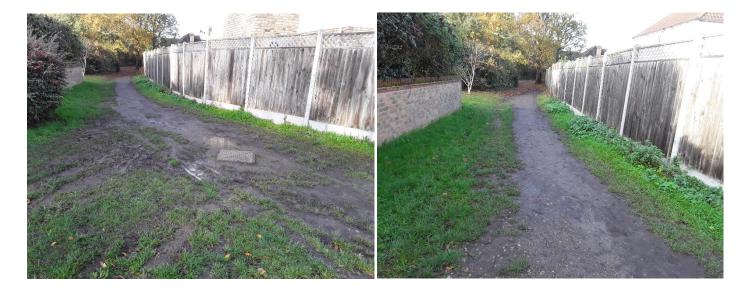
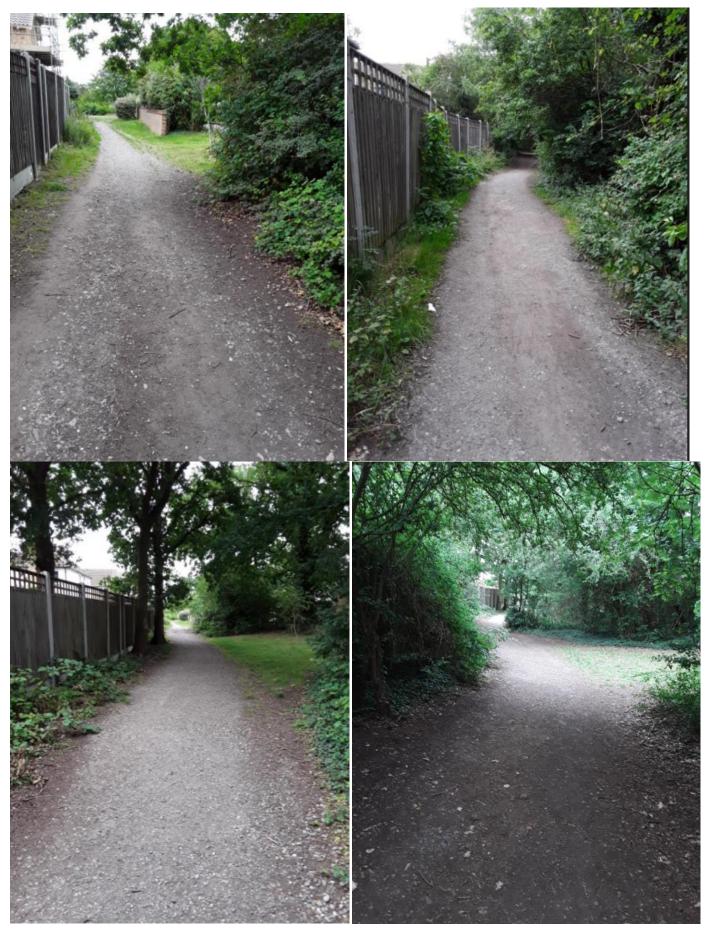
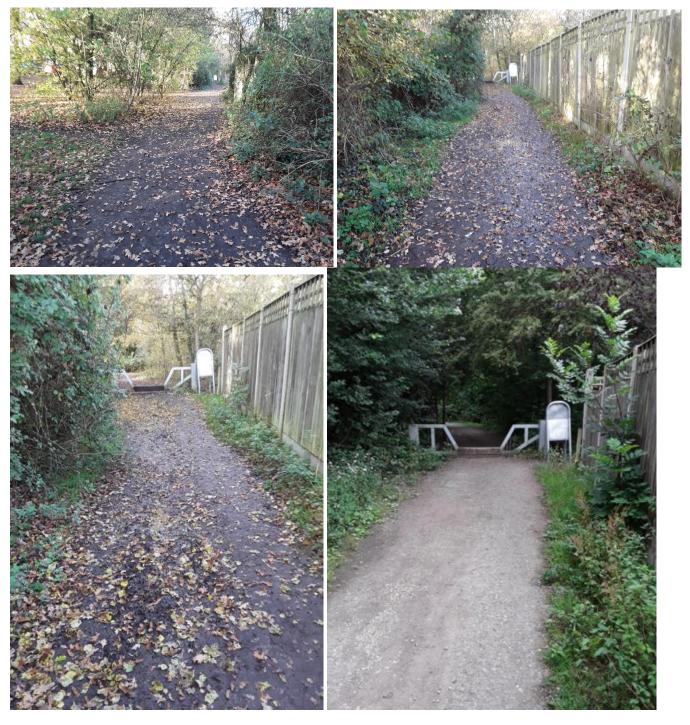
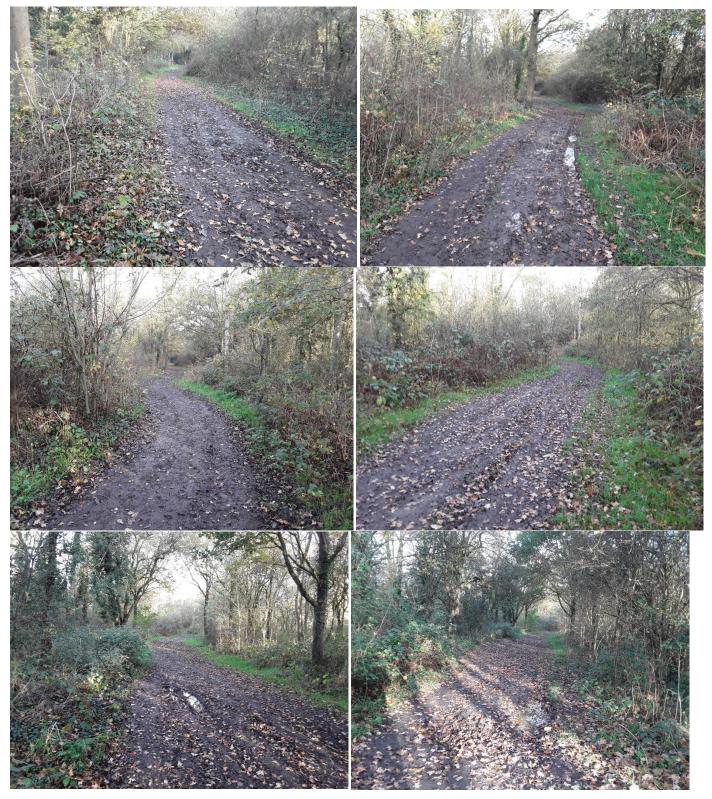
BEFORE

Local Highways Panel have received request to improve the condition of a PROW which is used regularly by local residents (many aged) gaining access to the Woodland and Essex Wildlife site. The PROW is a Public Bridleway.
